Reinforcement Project for Earthquake-Damaged Buildings in Albania, case study Durrës, Albania

The case study being presented is a 6 floors hotel with a wooden roof located in Durrës city. This structure was one among the many that was damaged during the earthquake that stroke on the 26 the November 2019. An evaluation of the damages needed to be made. Structural Building Codes Used The building in question was constructed in 1998, and the seismic design codes in effect at the time in Albania were KTP-78 and KTP-N2-89.^[2] These codes governed the structural design of the building, including aspects related to seismic resilience. On the KTP-78 code the design of reinforced concrete, steel, wood and masonry structures is performed using the limit state design, which takes into account the free and imposed vibrations, the deformed shape of the structure.

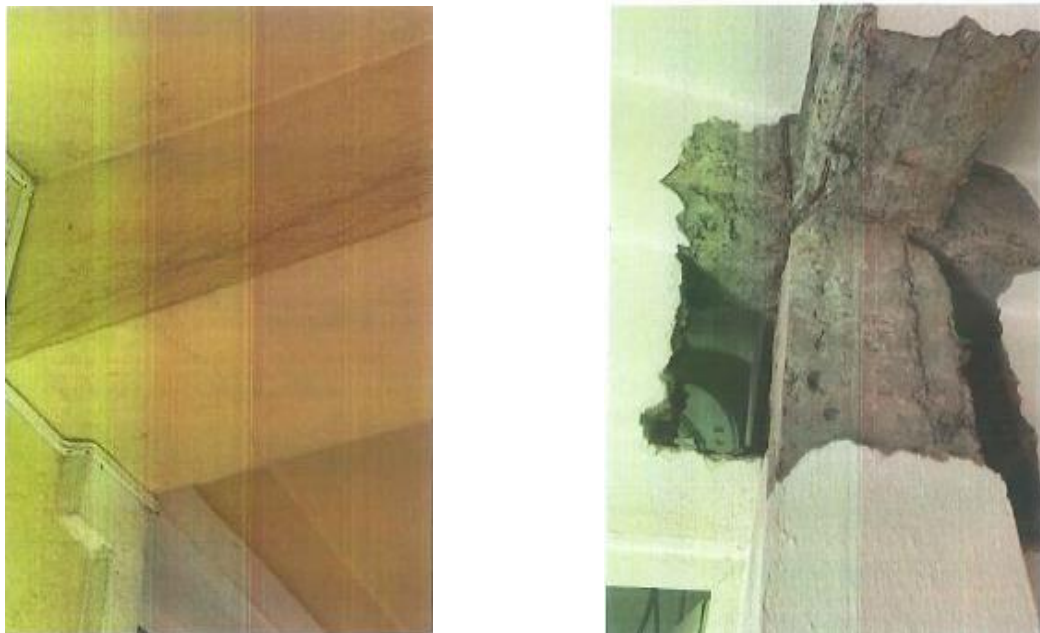
Based on observations, the existing condition of the building appears problematic. Small cracks have been identified in the masonry partition walls and at the joints between walls. Additionally, damage or cracks have been observed in slabs, beams, and columns, particularly in critical areas. The cracks are small in size and not continuous.

Fig. 3 Photos showing some of the inspections carried out after the Durrës earthquake of November 26. [2]

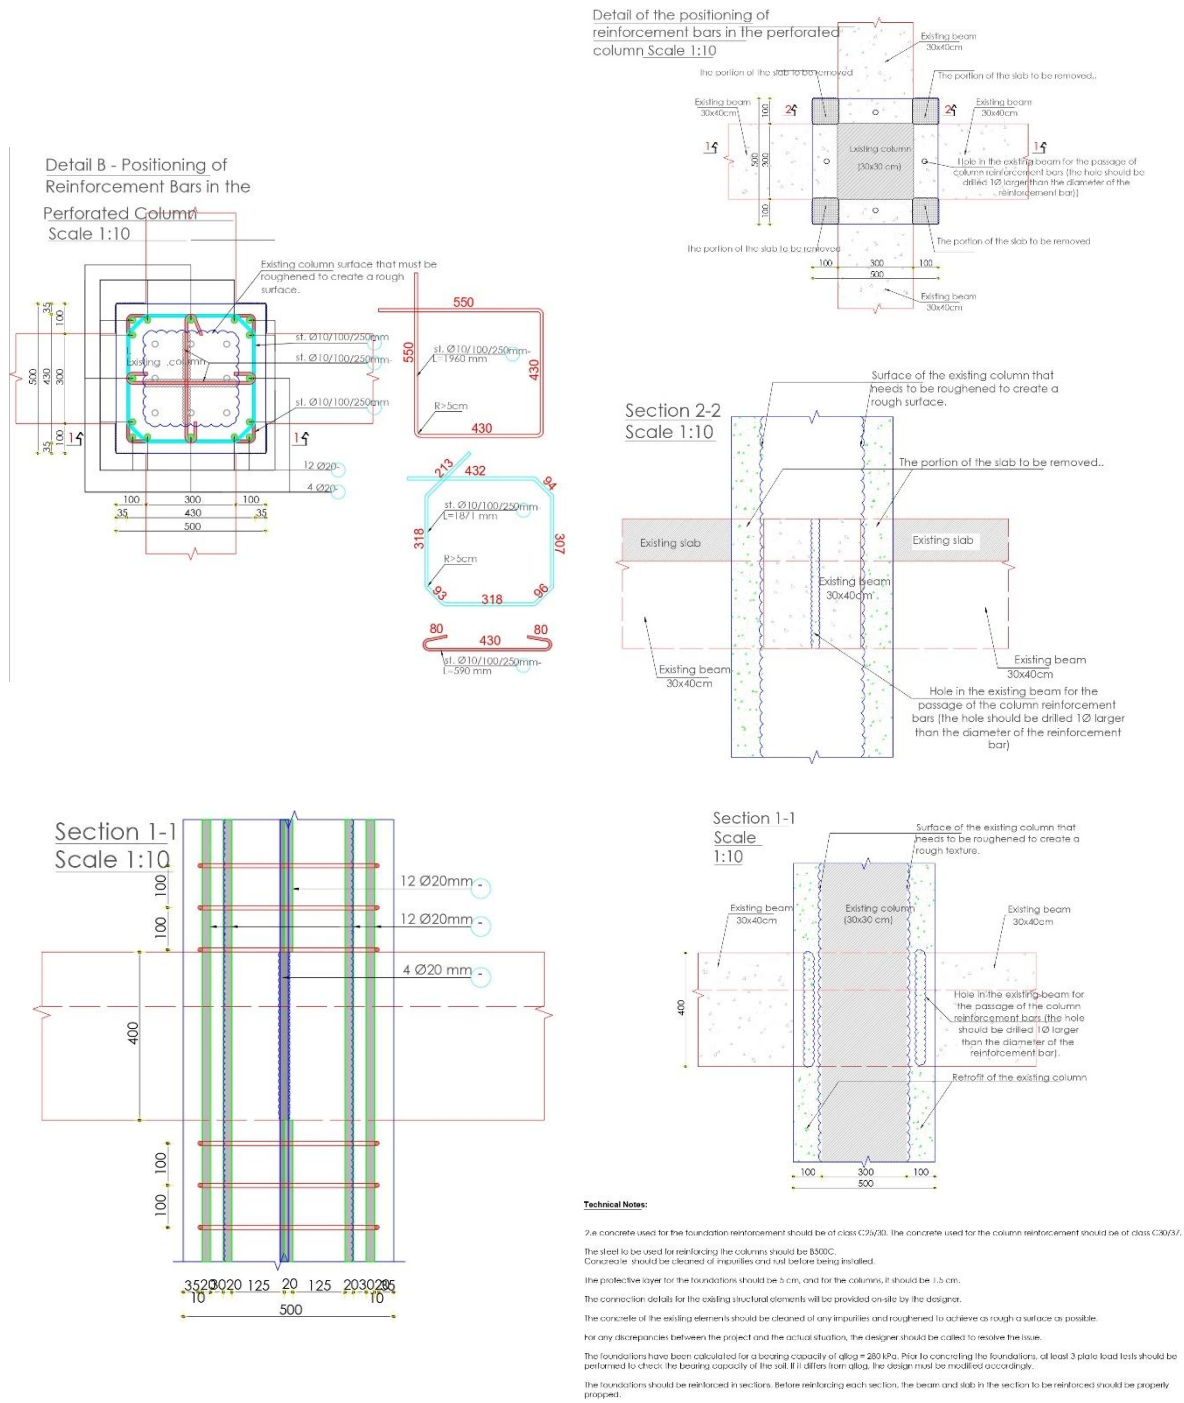
Fig.9 Details – Positioning of Reinforcement Bars in the Perforated Columns [2]

Based on the results of the calculations and the observations made on the structure, we conclude that the building does not meet the required performance levels and urgently needs to be retrofitted in order of it to fulfilling the requirements of the structural response needed. The form used to the reinforcement will be meshing/jacketing of the columns/beams. Jacketing is a very common method use for strengthening of columns/beams. The most common types of jackets are steel jacket, reinforced concrete jacket, fiber reinforced polymer composite jacket, jacket with high tension materials like carbon fiber ,etc. The main reason we use jacketing is to increase in the shear capacity of columns in order to accomplish a strong column-weak beam design, to improve the column's flexural strength, to increase concrete and shear strength confinement by transverse fiber reinforcement, to increase flexural strength by longitudinal fiber reinforcement provided, that are anchored at critical sections. [6] In traditional reinforced concrete jacketing, the section of the column is enlarged by casting a new reinforced concrete/mortar section over a part or the entire length of the column. The new section is bonded to the original section through anchor rebars or high-strength bolt. [5]
