Electrical Fault Analysis of 33KV Distribution Network (A Case Study of Ekiti State 33KV Distribution Network)

Kehinde Olusuyi , Temitope Adefarati, Ayodele Sunday Oluwole, Adedayo
Kayode Babarinde

Abstract: - The aim of this research work is to carry out a fault analysis of 33KV distribution system using Ekiti state as a case study. Based on the available statistical data, Ekiti State is reported to suffer from severe shortages of electric power due to dilapidated and outdated electrical power infrastructures. In this research work, electric power infrastructure and energy availability in Ekiti State is studied since the state is one of the principal economic and political hubs of Nigeria. During the study, the conditions of all relevant electrical facilities for distributing power at the 33 KV level were assessed. Power availability in the 33/11kv injection stations in the state was considered by collecting data about energy supplied, faults and other outages. The outcome of the research indicated that the probability of having 2 consecutive hours of power was less than 25% in either year for most of the feeders indicating a very poor situation for consumers, especially small s

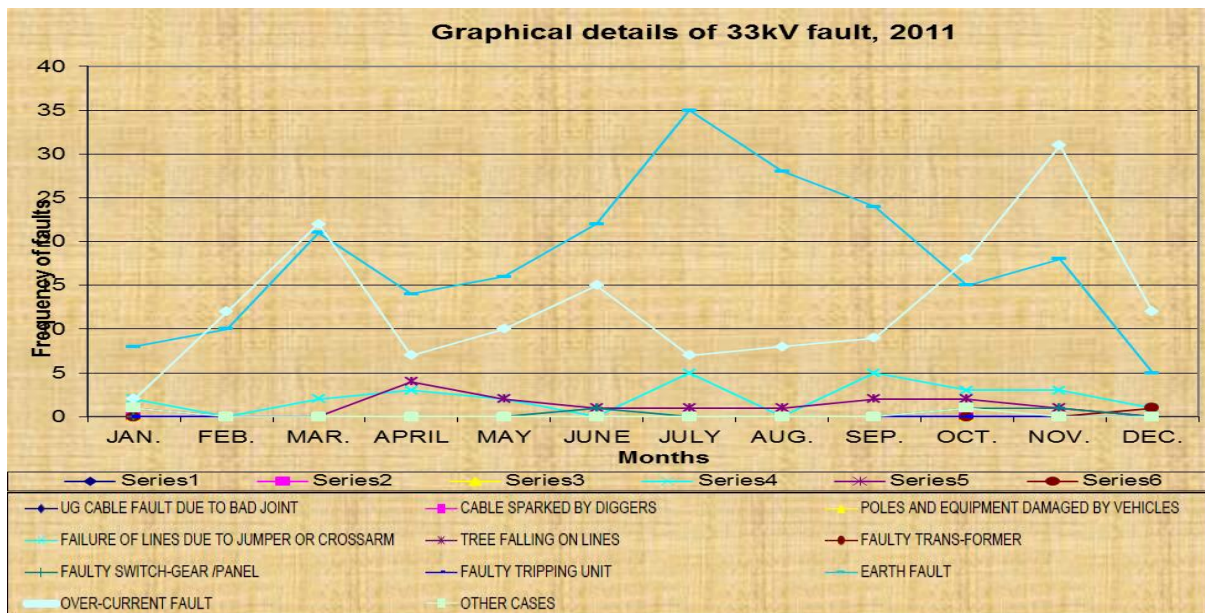
Fig 1:Graphic representation of faults that occurred on 33KV system in Ekiti State(2011)

The following tables provide a graphic representation of the physical state of the components of the 33kV network in Ekiti State. The poor state of the lines accounts for the incessant outages and faults observed as shown in fig 1-fig 3 and Table 1-Table6. Inspection of the overhead lines revealed that in Ekiti-State, the supporting structures of the distribution systems are predominantly either reinforced concrete or wooden poles with a few steel towers, similarly with either wooden or steel cross-arms. The abundance of trees in Ekiti-State’s forest makes the use of wood as supporting structures very economical. Most of the ‘right-of-ways’ in Ekiti-State pass through the forest due to the nature and topography of the state. However, the distribution networks were characterized by leaning poles or crooked structures, shattered insulators, broken or decayed cross-arms and vegetation encroachment. The data collected was compiled into a spreadsheet resident database from which many scenarios and analyses were deduced. Based on the findings in the data collected, the physical condition of the overhead lines, the substations as well as other relevant system components were assessed so that remedial measures could be determined. Power availability, loading characteristics of the district and probabilistic characterization of faults in the state were also carried out. Faults experienced on the 33kV distribution network of Ekiti State district between 2011 and 2013 were obtained from the Power Holding Company of Nigeria PLC (PHCN); the database contains details of types of fault cleared on a monthly basis for the period 2011 and 2013 on the 33kV network.

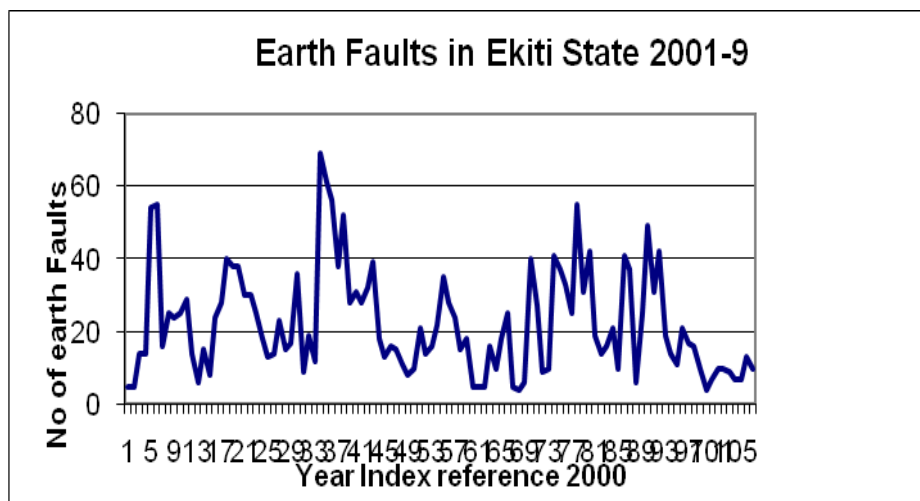
Fig 4: Earth Faults on 33kV network between 2001 and 2009

The fig 4 gives a plot of the frequency of earth faults observed on the 33kV network with year index reference 2000.

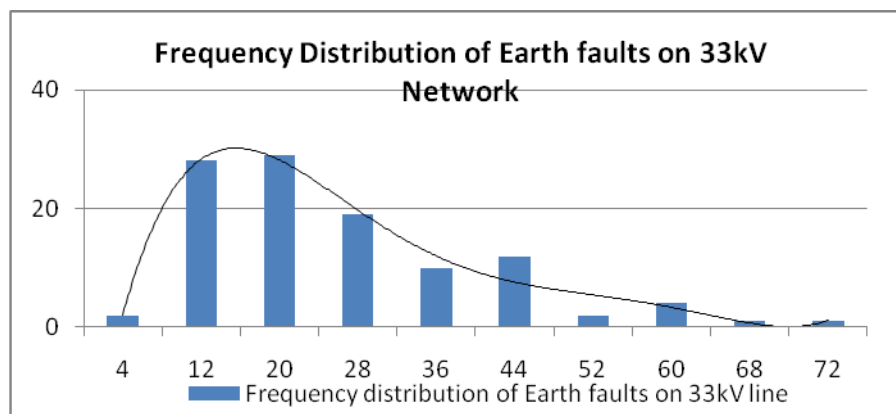
Figure 5: Frequency Distribution of Earth Faults on 33kV Network

The frequency distribution for the earth faults observed on the 33kV network is shown in fig 5.
