Determination of structural behavior of a unreinforced masonry Clock Tower using FEM analysis

ABSTRACT : In this paper it is presented the structural assessment of the Clock Tower found in the castle of Preza, an old historical landmark built during the beginning of 15th century. The structural behavior is analyzed using FEM modeling in order to examine at what extent the structural defects endanger the stability of the tower also considering the geotechnical properties of the soil under the basement of the tower. The geometrical data are acquired by means of terrestrial laser scanner (TLS). Mechanical properties of the constituents were defined through experimental tests on stone samples extracted from the tower. As a result, a better overview of the structural conditions is established and improvement techniques are suggested in order to enhance the performance under both static and dynamic loads.

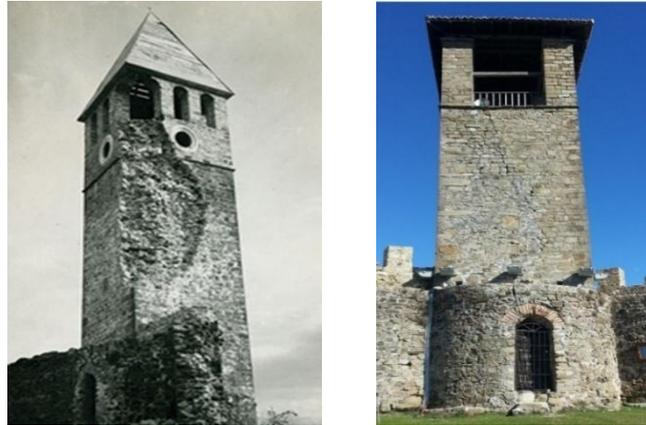
Figure 1. Clock tower: the past (a) and present condition (b)

The tower had a large rosette window, on the outside executed in brick work, in Ottoman style. Nowadays, the top of the tower has been modified and the clock and window are missing. However, it should be mentioned that during its existence the tower has been damaged and repaired several times, mostly due to earthquakes (Fig.1) [6].

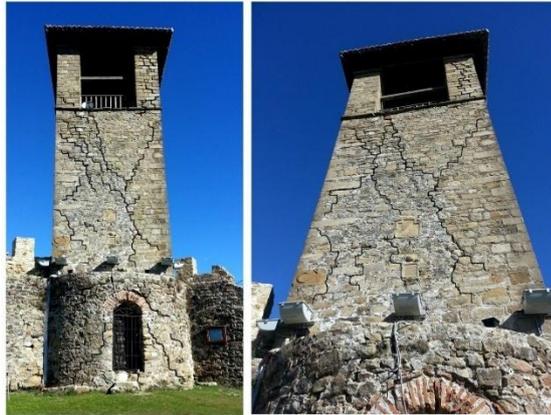
The results of the damage survey showed that there is a need for intervention in order to improve its structural performance under cyclic loads. There are a diffuse series of visible cracks present in all façades of the tower (Fig.4). It is seen the propagation of cracks from top until the bottom of the tower. It is believed that seismic loads are one of the main causes of these cracks.

Moreover, from the archive, it was stated that the tower has been repaired several times. The materials used for repair might have had different properties than the original ones, thus many of the surface cracks could have been formed.

Figure 4. Structural cracks found on the main façade.

Injection is suggested to be used in areas where non-structural cracks less than 10 mm wide are found. The most useful feature is the increase of continuity of masonry. Furthermore, neither aesthetics nor architectural features of the mosques will be altered when applied.

In order to increase ductility of the structure, it is suggested to insert longitudinal FRP bars bonded with epoxy resin or mortar at different levels. Additionally, local reconstruction “cucci scucci” technique is suggested to be used in the places sanding phenomenon is seen and where massive loss of building units is observed. The substituting units must have to the same architectural features, and should be compatible with original facades.

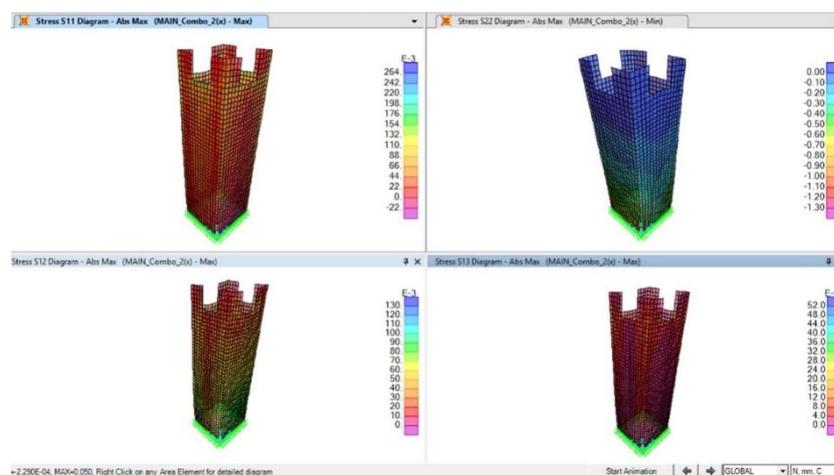
The hoop stress (S11) on the walls varies from -0.274 to 0.244 MPa. S22 ranges between -1.368 to 0.34 MPa. Maximum concentrations are located at the bottom parts of the load bearing walls (Fig.6). The response spectrum analysis results of the undamaged model have shown that the effect of the seismic loads is felt the same in both directions as the structure has a squared plan and with no irregularities. The maximum displacement is 5.4 mm at the top of the tower.

Figure 6. Example of stress distribution after analysis.
