Environmental Aggression and Corrosion of Reinforcements. A Real Case.

M. López-Alonso¹, E. Jadraque-Gago¹, A. Galán-Díaz², J. Santamaría-Arias²

¹Universidad de Granada (Spain) ²Isolux Corsan-Corviam

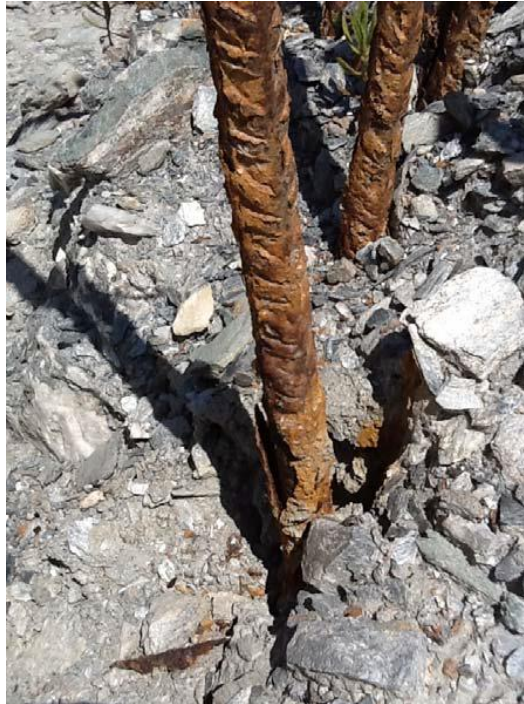
Photo 1: Corroded reinforcements.

As seen in the table above, for all structures, the maximum loss of resistant area is similar and always below 4.5%, whilst average loss falls between 2.5 and 3.2 %.

According to the results in Table 2, loss of area never exceeds 4.5%, therefore section loss caused by corrosion of reinforcements is admissible.

The average resistant section losses to corrosion are around 3%, the maximum losses are below 4.5%. As for adhesion, the results of the tests show “ τ_{bm} ” and “ τ_{bu} ” values far above those prescribed by Article 32.2 of the EHE-08, and furthermore the geometry of the corrosion falls within the values stated in the corresponding adhesion homologation certificates. As stated in EHE-08 Article 32 “Steel for passive reinforcements”, the equivalent section must not fall below 95.5% of the nominal section. However Articles 69 and 88 of the EHE-08 advise against the use of passive reinforcements which have suffered a weight loss due to corrosion of over 1%. Structural tests are therefore essential on piles and abutments where losses have been detected to confirm structural safety. These safety tests have been satisfactory in every case.

Given that loss obtained through corrosion is similar in all structures, a constant loss is considered at 4.5%. Coefficients of safety for each element and structure have been compared with the reinforced section where no loss is incurred. This brought to light the fact that in all cases, the coefficient of determination was above a unit, so no additional reinforcement is required.

Regarding security tests against breakage in the starting sections, bearing in mind losses of section of passive reinforcements caused by corrosion, and considering the loss of bars used in the laboratory tests, in all cases the coefficient of determination was always superior to a unit, so no additional reinforcement was required.
