Reliability of Non-Destructive Test Results for Assessment of Concrete Using Cut and Pull Out Test & Rebound Hammer Test (A Case Study)

ABSTRACT: Structural assessment of an old building of Directorate of Electronic Media and Publication (DEMP), Ministry of Information and Broadcasting, Government of Pakistan was carried out to assess repair and rehabilitation works. Non-Destructive Testing (NDT) Methods were used that included thorough visual assessments, complimented with two types of NDTs i.e Cut and Pull Out Test and Rebound Hammer Test. A total of 80 tests, 40 for each Rebound Hammer and CAPO Tests were performed at various locations of the building elements. The compressive strengths of concrete obtained by both these tests at different locations were recorded and standard deviations of Hammer readings at each test location were calculated. The indirect compressive strength of concrete obtained by the Hammer Test was compared with the compressive strength of concrete obtained by the CAPO Test. The results from both these tests were tabulated and interpreted to ascertain their reliability. It was concluded that the Rebound Hammer Tests can be recommended only as preliminary N

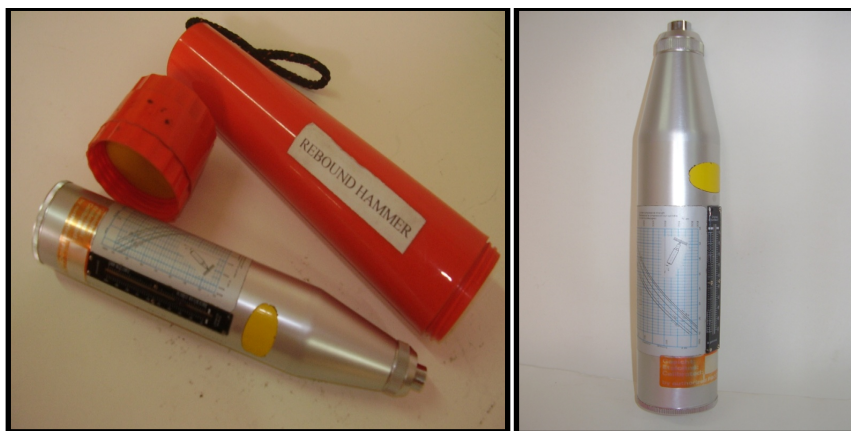
Figs. 1 and 2

The Rebound Hammer Test is performed as per ASTM C805. This test is convenient and provides a rapid indication of the quality of concrete. The rebound hammer consists of a spring controlled mass that slides on a plunger within a tubular housing. When the plunger of rebound hammer is pressed against the surface of concrete, a spring controlled mass with a constant energy is made to hit concrete surface to rebound back. The extent of rebound, which is a measure of surface hardness, is measured on a graduated scale. This measured value is designated as Rebound Number. A concrete with low strength and low stiffness will absorb more energy to yield in a lower rebound value. Thus, the hardness of concrete and rebound hammer reading can be correlated with compressive strength of concrete. The rebound value is read off along a graduated scale and is designated as the rebound number. (See Figs. 1 and 2)

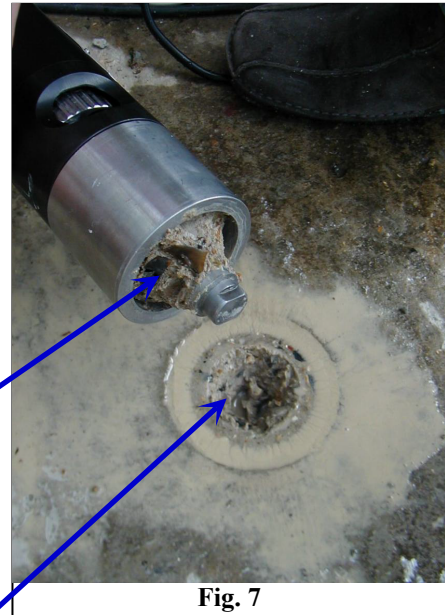
Fig. 7

Crushed material

Sharp 55 mm diameter edge from counter pressure free from any cracks

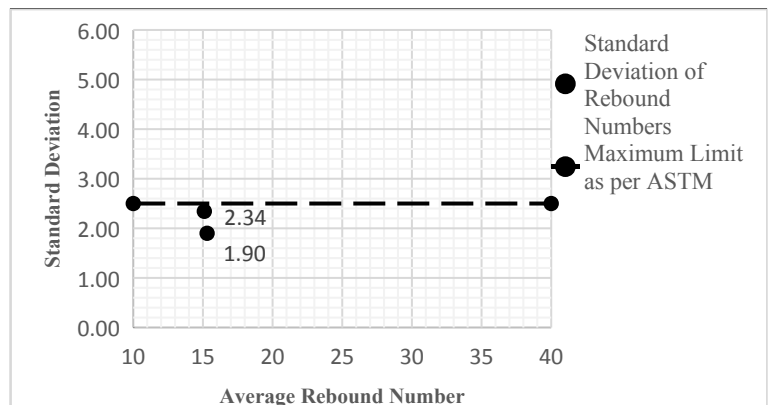
The standard deviation of the rebound readings at Test Mark Nos. 19 and 20 are 2.34 and 1.90 respectively. The average standard deviation of these two tests is 2.12, which is less than 2.5 (maximum allowable standard deviation as per ASTM C-805) which implies that the test data is not too scattered.

The average rebound number for Test Mark Nos. 19 and 20 are in the range of rebound number 15. This number is not defined on the correlation curve of the instrument.

Fig. 9: Average Rebound Number VS Standard Deviation (Test Mark Nos 19 and 20)

The 02 nos. test results for Foundation shown in Table III/a are graphically represented in Figs. 9 and 10.

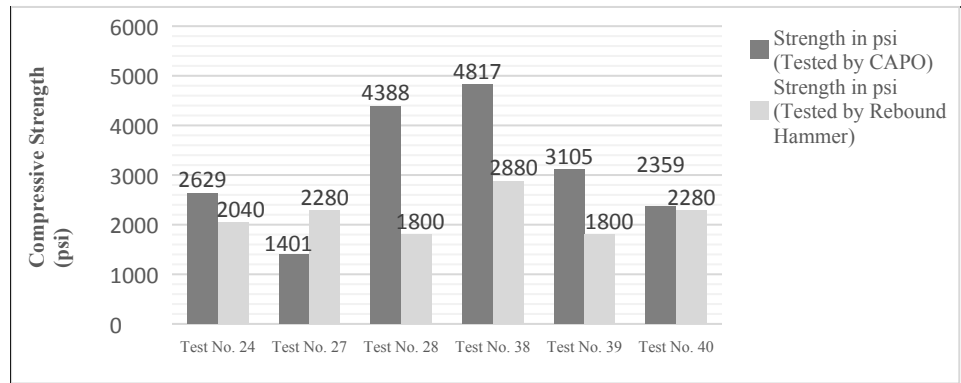
The CAPO Test results at Test Mark Nos. 24, 27 and 40 indicate that the cube compressive strength of concrete is less than 3,000 psi (Minimum strength required as per ACI Code 562-19) as well as less than of minimum design strength requirement of 2,500 psi in structural element except test Marks Nos. 24 as per ACI Code 318-14.

However, the cube compressive strength at Test Marks Nos. 28, 38 and 39 satisfy both minimum strength required as per ACI Code 562-19 as well as minimum design strength requirement for structural element as per ACI Code 318-14. % Difference of concrete strength tested by CAPO and Rebound Hammer is summarized as under where negative value indicates that strength tested by CAPO test is lower than tested by Rebound Hammer and vice versa.

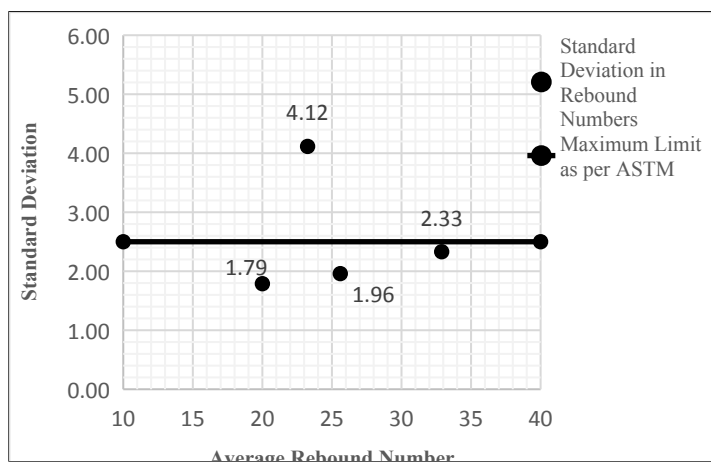
Fig. 19: Average Rebound Number VS Standard Deviation (Test Mark Nos. 01, 04, 07 and 09)

The average rebound number for Test Mark Nos. 01, 04, 07 and 09 are in the range of rebound number 20 to 26. The 20 number is not defined on the correlation curve of the instrument. The minimum value on the correlation curve of Rebound Hammer is 22 that corresponds to $f_c' = 1,500$ psi. It is therefore inferred that equivalent cylinder compressive strength of concrete at the said location is less than 1,500 psi. Similarly the strength corresponding to rebound number 26 is $f_c' = 2,640$ psi. Therefore, the quality of concrete at this location is classified as fair concrete.

The test results for 04 nos. beams (Load Bearing Structure, Ground Floor) shown in Table III/f are graphically represented in Figs. 19 and 20. The tests were conducted on beams at ground floor. The standard deviation of the rebound readings at Test Mark Nos. 01, 04, 07 and 09 are 4.12, 1.79, 2.33 and 1.96 respectively. The average standard deviation of all tests is 2.55 which is more than 2.5 (maximum allowable standard deviation as per ASTM C-805) which implies that the test data are too scattered.

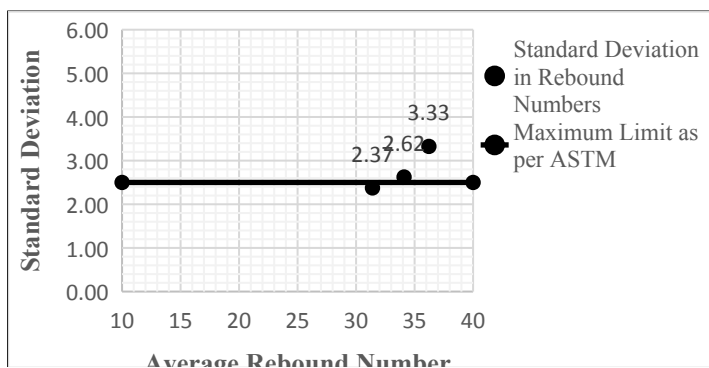
The average rebound number for Test Mark Nos. 10, 12 and 14 are in the range of 31 to 36. The 31 number corresponds to compressive strength $f_c' = 3,480$ psi while that of 36 is $f_c' = 5,040$ psi. Therefore, the quality of concrete at this location is classified as good layer concrete.

Fig. 23: Average Rebound Number VS Standard Deviation (Test Mark Nos. 10, 12 and 14)

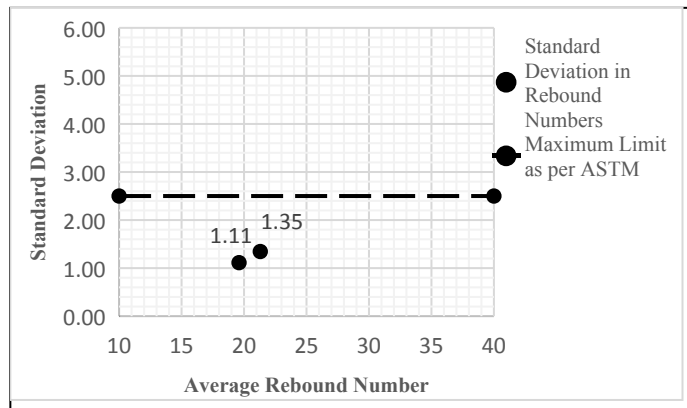
The average rebound number for Test Mark Nos. 06 and 17 are in the range of 20 to 21. The 20 number is not defined on the correlation curve of the instrument at an instrument angle of +90°. The minimum value on the correlation curve of rebound hammer is 27 that corresponds to $f_c' = 1,600$ psi. It is therefore inferred that for 20 to 21 rebound range the equivalent cylinder compressive strength of concrete at the said location is less than 1,600 psi. Therefore, the quality of concrete at this location is classified as fair concrete.

Fig. 27: Average Rebound Number VS Standard Deviation (Test Mark Nos. 06 and 17)

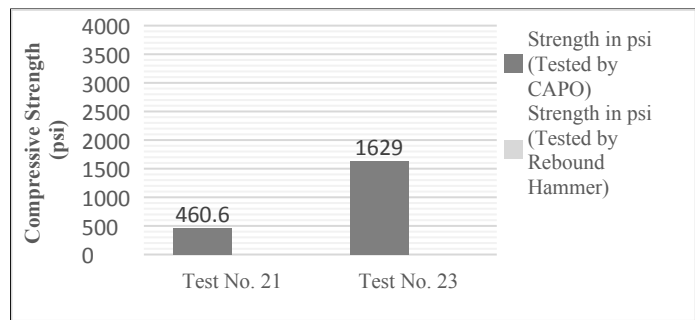
Note: The value of compressive strength tested by Rebound Hammer has not been plotted in the above figure as the hammer reading is not defined/not applicable on the correlation curve of the rebound hammer.

Fig. 30: Compressive Strength of Concrete Tested by CAPO and Rebound Hammer (Test Mark Nos. 21 and 23)

02 nos. test results for slab (Load Bearing Structure, First Floor) shown in Table III/k are graphically represented in Figs. 29 and 30. The standard deviation of the rebound readings at Test Mark Nos. 21 and 23 are 2.33 and 4.0 respectively. The average standard deviation of all tests is 3.26 which is more than 2.5 (maximum allowable standard deviation as per ASTM C-805) which implies that the test data are too scattered.

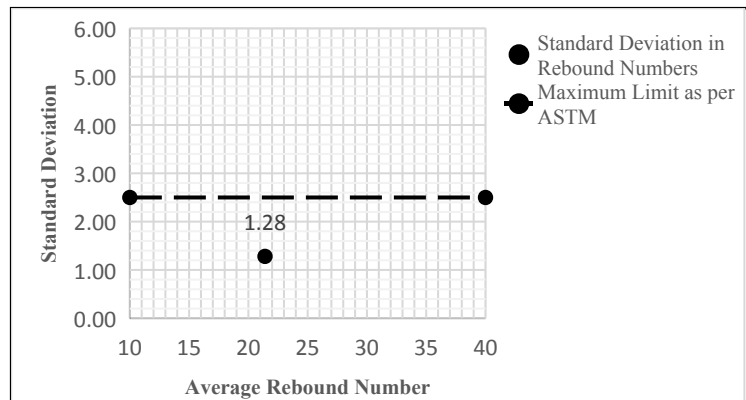
The average rebound number for Test Mark Nos. 22 are 21. The 21 number is not defined on the correlation curve of the instrument at an instrument angle of $+90^\circ$. The minimum value on the correlation curve of Rebound Hammer is 27 that corresponds to $f_c' = 1,600$ psi. It is therefore inferred that for 21 rebound number, the equivalent cylinder compressive strength of concrete at the said location is less than 1,600 psi. Therefore, the quality of concrete at this location is classified as fair concrete.

Fig. 33: Average Rebound Number VS Standard Deviation (Test Mark No. 22)
