## Material Destruction in D'Aronco's Works of Art

Sibel Onat Hattap

Botter Apartment - İstiklal Street 473- is the first significant urban scale example of Art Nouveau (new art) architecture in Istanbul. The apartment has taken its name from Dutch origin J. Botter who was the official tailor Abdülhamit II and the palace. Jean Botter was a famous fashion designer in addition to being the official tailor of the Sultan. Sultan Abdülhamit decided to build Botter Fashion House in Pera in order to display his appreciation to him. The famous Italian architect Raimondo D'Aronco was selected for this task. The building has become the most famous construction of Pera in a short time. European fashion was being introduced here and fashion shows were organized for upper class of Istanbul. Botter Apartment is a masonry building composed of 2 Basements+ground floor+4 normal storeys+a half storey (Figure 2). Construction date is 1900. The typology that has been applied was constructed on a narrow long parcel and that is a building typology where residence and commercial functions exist together (ground and first floor were Botter's office, and the upper floors were designed as residence) and h

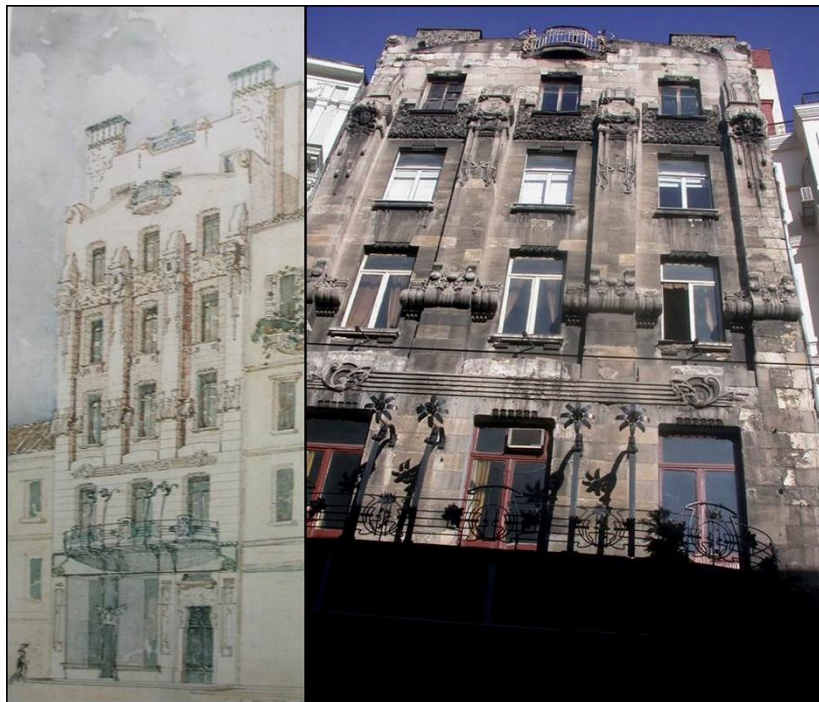
**Figure 1.** Botter Apartment [1] **Figure 2.** Botter Apartment, (S.O.Hattap)

The facade width of Botter Apartment is 11 meters and its depth reaches up to 42 meters. As the typical examples of Art Nouveau architecture, rose figures were used abundantly on the facade of Botter Apartment. This is apparent on the pattern taken into a frame on the entrance door, finish embossments of plasters on the lateral facade and occasionally on window embossments. The Art Nouveau effect culminated on cast irons of the balcony. The balcony interlocked to the building with 4 curvilinear cantilever arms.

The balcony that is currently a designing wonder is actually safety-critical. A wide eaves was constructed in front of the ground floor shop because of the falling hazard at any moment. The eaves which was made by 2001 is still existing and casts a damper over architecture aesthetic.

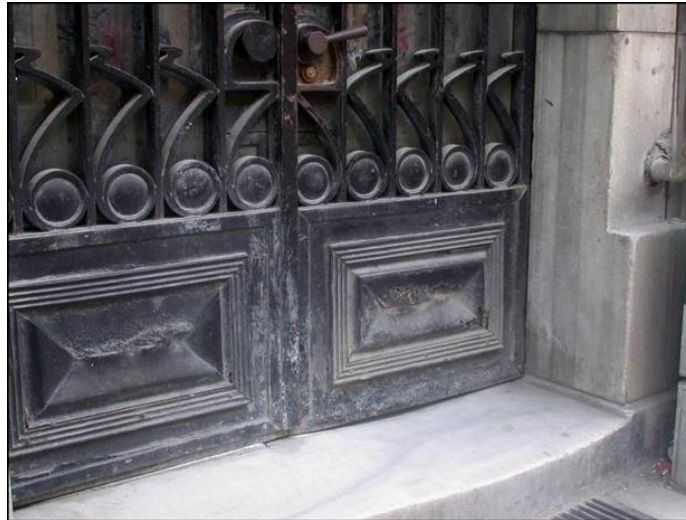
Metal wings of the entrance door lost their strength while trying to preserve their originality, corrosion is peaking and component breakages started (Figure 3).

**Figure 3.** Deflection and material loss occurred by reason of usage at marble step (S.O.Hattap)

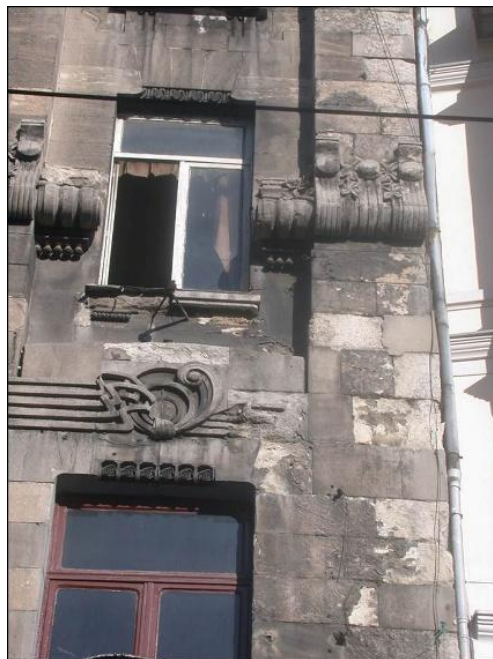
All traces of deterioration mechanisms are apparent on the stone material at the facade. One of the most important problems here is degradation, namely wearing down occurred on the natural stone material used and the fact that material started to disappear by losing its properties (this is also defined as disintegration in some literatures). Degradation results from atmospheric conditions (exposure to atmosphere effect - weathered), it may be distinguished with the lack of mineral binder (legante) in stone materials and less level of compactness (tightness solidness) compare to a proper stone at deteriorated areas caused by this and higher level of porosity. In cases the measures necessary for protection of natural stone material against external effects not only aesthetic but also structurally significant problems emerge as in the case of this building. The surface formation called Patina is visible on the Facade Stone Material and a black color layer is seen on stone surfaces particularly those which are not washed with rain.

Air pollution, some particles such as smoke, fume etc. on the atmosphere, sulfur oxide materials have reacted with substances which include limy calcium and calcium sulphate-gypsum was formed. Surface erosion occurred by disintegration occurred on the material by combination of mineralogical structure of Stone Material and some deterioration mechanisms in rain water such as acids and salts.

**Figure 4.** Occurrence of disintegration-surface erosion on the material by combination of mineralogical structure of Stone Material and some deterioration mechanisms in rain water such as acids and salts (S.O.Hattap)

The referred procedures should be exactly implemented for stone materials which have been mostly damaged in Botter Apartment. Wrong practices such as sandblasting held to clean facade, dredging (mechanical cleaning) result in detail and material loss. It would be right to use laser as the cleaning method for such a valuable work of art. Even though it is expensive, particularly rose patterns would not get highly damaged with this method. This significant this here is to determine reflection range carefully in the laser method, painting works performed on the stone in the name of repair give rise to irremediable faults.
