Temperature fluctuations and moisture level in external walls. Case study Tirana, Albania

The aim of this paper is to experimentally study the thermal performance of walls with various types of thermal insulation, including the ventilated façade system, as well as walls without thermal insulation. The purpose of the study is also to show how the technical and architectural methods utilized during construction affect the moisture and temperature fluctuations of the perimeter walls.

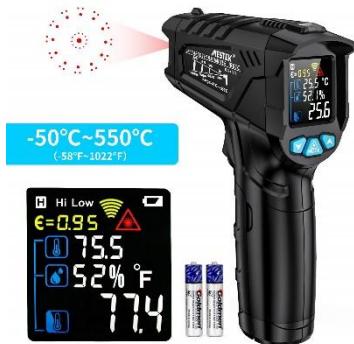
Fig.6 MESTEK-INFRARED THERMOMETER.

For the measurement of the temperature of the walls was used, the device "MESTEK - INFRARED THERMOMETER", while for the measurement of the moisture level in the external and internal walls, the device "SILVERLINE - Digital Moisture Meter" was used.

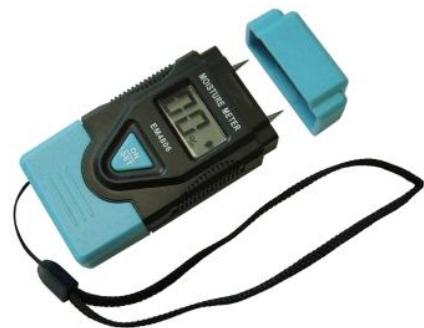
Fig.7 SILVERLINE - Digital Moisture meter.

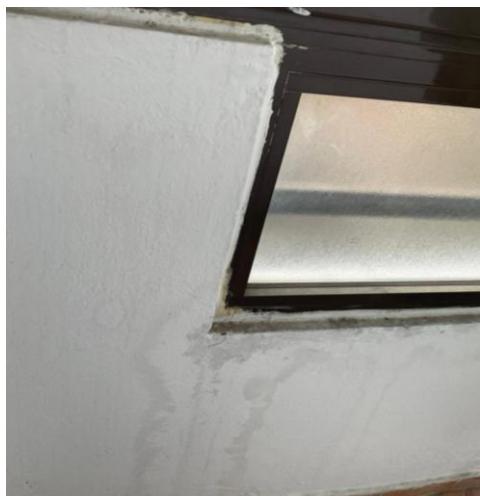
Fig.17 Visible moisture on the wall, Building A
Source: Authors

On the other hand, the wall without thermal insulation had visible signs of moisture (max 1.9%) and high heat loss, hence a large amount of energy is needed to keep the temperature constant in the interior.

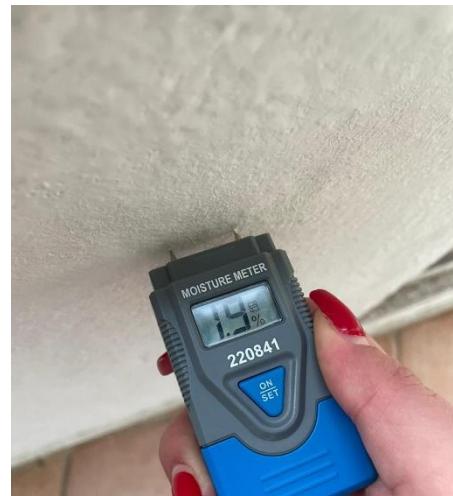
Fig.18 Corresponding moisture value (%)
Source: Authors

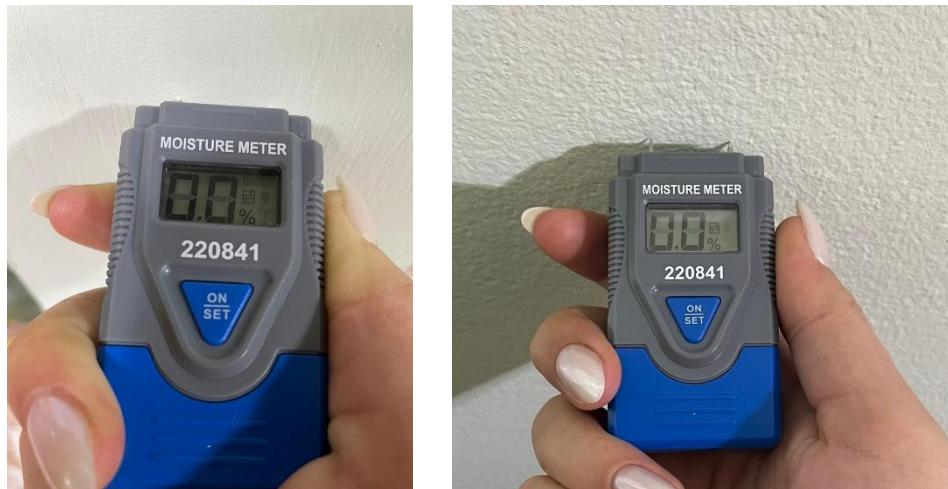
Fig.21 and Fig.22 Moisture value on the ventilated façade system, Building B Source: Authors

The moisture level in the thermally insulated wall is extremely low, ranging between 0%-0.1%. This demonstrates that the ventilated facade system performs admirably in terms of humidity.
