Case Study in Durrës, Albania: Temperature and moisture differences between a non-thermally insulated wall system and an external thermal insulation composite wall system (ETICS).

This research provides a comparative analysis of thermal and moisture performance of two types of masonry wall systems. The buildings investigated are in the Spitala area of Durrës, Albania and share identical climate conditions. The two wall typologies that were examined were: an uninsulated wall consisting of a 25 cm brick layer with plaster, and an external thermal composite system, referred commonly as ETICS. Thermal and moisture measurements were performed at multiple points of each wall with the help of specialized instruments.

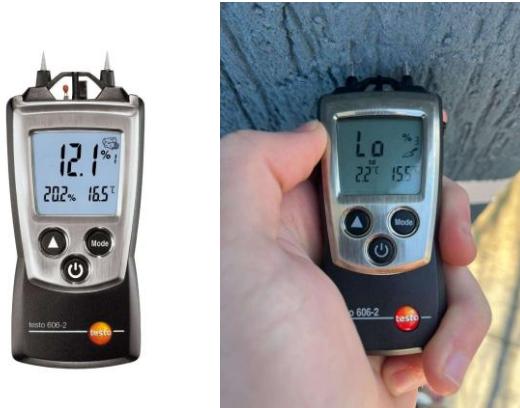
The “TESTO 606-2 Digital Humidity and Temperature meter” was utilized to assess the temperature and moisture levels in both external and internal walls. Both buildings are single-story villas, with data taken at intervals of roughly 100 cm along the perimeter walls, both externally and interior. The measurements were conducted on 15 January 2026 at the Spitallë area in Durrës, Albania. [2]

Fig. 2. TESTO 606-2 material temperature and moisture measuring instrument

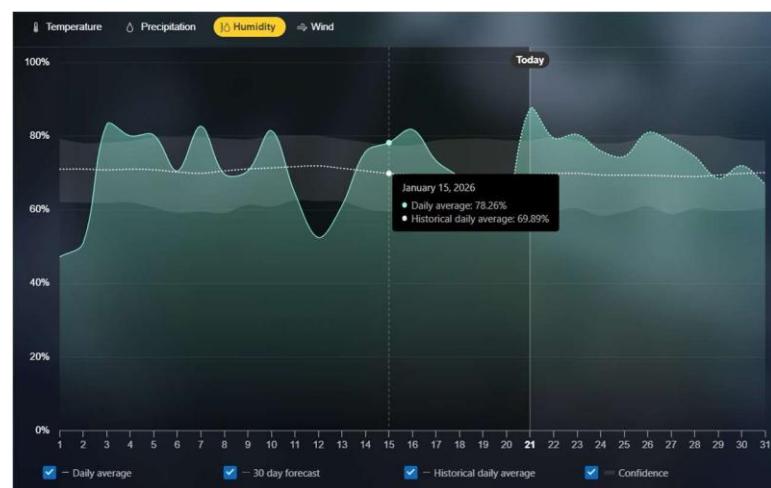
Fig. 3. Daily humidity line chart, annotated for January 15, 2026, in Spitalë, Durrës, Albania.
Source: Msn Weather website.

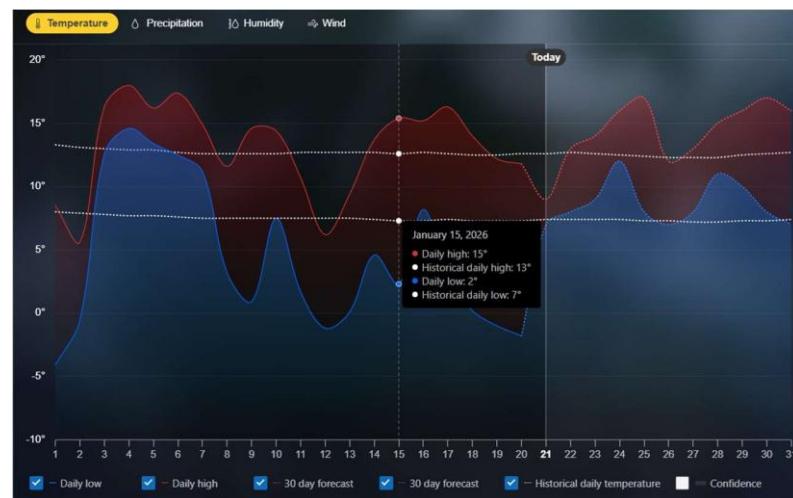
Fig. 4. Daily temperature line chart, annotated for January 15, 2026, in Spitalë, Durrës, Albania.
Source: Msn Weather website.

The temperature ranged from a minimum of 12.8°C to a maximum of 13.8°C. The buildings under consideration are fewer than 5 m apart.

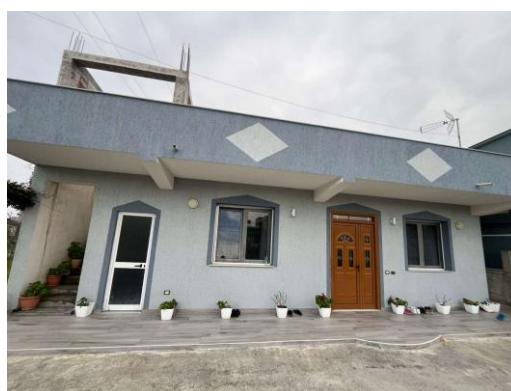
Building A – It is built without insulation, merely with a wall system consisting of 25-cm brick breadth and plaster. It was built earlier than Building B.

Fig. 7. Photograph taken of the exterior wall of Building A

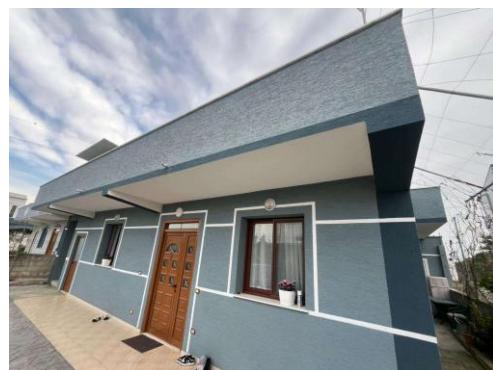
Building B – Includes a multi-layered exterior wall system that integrates insulation and water-resisting materials.

Fig. 8. Photograph taken of the exterior wall of Building B

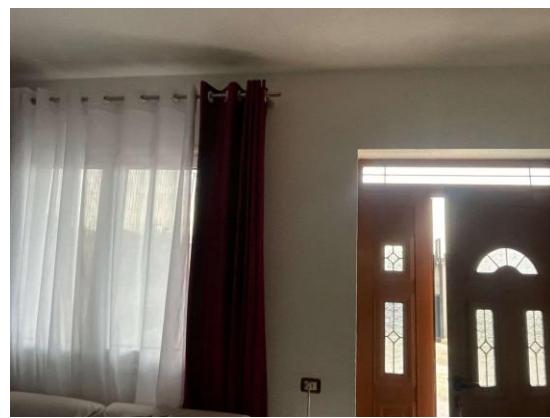
Fig. 12. The internal face of the external wall, Building A
