## Techniques for Improving Assessment of the Seismic Vulnerability of a Masonry Bell Tower

Domenico Colapietro<sup>1</sup>, Fabio Fatiguso<sup>1</sup>, Marco Pinto<sup>2</sup> and Francesco Bianco<sup>2</sup>

<sup>1</sup>DICATECh, Technical University of Bari, Bari, Italy

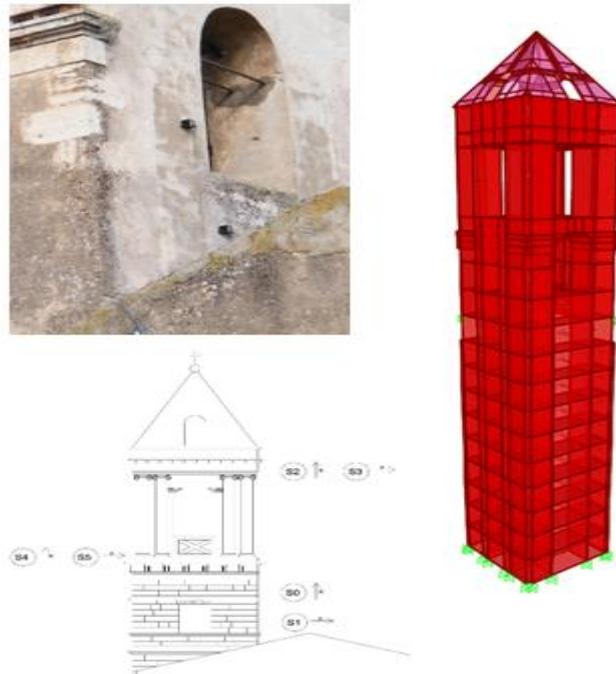
Figure 4: Location of the vibration sensors Figure 5: Finite element model

The instrumentation used for dynamic monitoring included a data acquisition system (THOR, www.waveng.it) based on force-balance accelerometers (EpiSensor ES-U2 Kinematics) (Fig. 4). It is able to manage more distributed sensor networks with real-time acquisition and data processing for structural analyses.

The tests were carried out by considering the action of the traffic and wind, acting on the bell tower in the months of November and December 2015. A preliminary three-dimensional solid element model was developed for selecting the location of the accelerometers during vibration testing. The construction of the model was undertaken using SAP2000© (version 14.2.4) and it is shown in Figure 5. Only structural elements were included in the model whereas non-structural elements are considered as extra masses. A relatively large number of finite elements (8-node brick element) have been used in the model so that a regular distribution of the masses could be obtained.

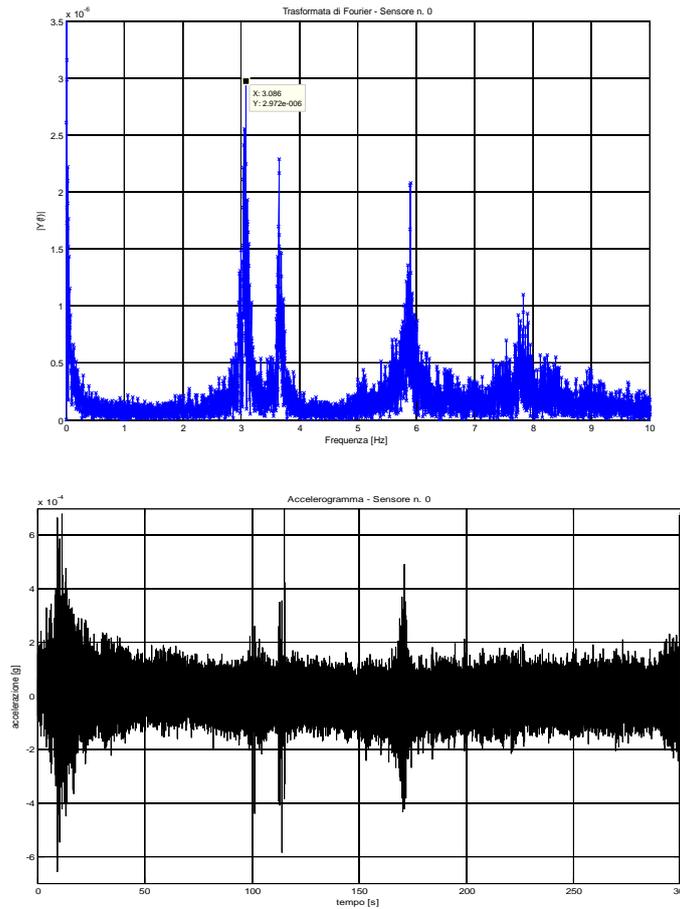
Figure 6: Fast Fourier transform and recorded signal. Accelerometer 0.

The aim of the structural identification was the verification of the Young's modulus of the masonry in the upper and lower part of the tower, acquired by non-destructive tests so as to optimize consequently the degree of constraint provided by surrounding buildings. In particular, the range of the Young's modulus is 1500÷1980 MPa for the bottom body (masonry in hewn stone with good weaving) and 2400÷3200MPa (masonry in block squared stone) for the top body. The dynamic measurements were carried out inside a 0÷5 Hz frequency range which is selected on the basis of the first six natural frequencies of the tower obtained from the modal analysis. From the spectral analysis of the acquired signals, natural frequencies and the corresponding vibration modes were formed. Since the recorded signal, as well as the signal-to-noise ratio, is proved to be rather low, this was amplified and filtered through a 30 Hz low-pass filter. Data acquisition was driven by software, which allows the acquisition of signals with sampling rate of 1000 Hz, and the real time visualization of accelerograms and Fourier spectra. The identification was performed by using the techniques of modal extraction in the frequency domain (frequency domain decomposition - FDD). These techniques allow evaluating the natural frequencies and modal shapes of the tower. Fast Fourier Transform (FFT) was used to determine the frequency spectrum of the signal. The spectral analysis of the recorded signals gives the natural frequencies and the corresponding mode shapes (Fig. 6-7).

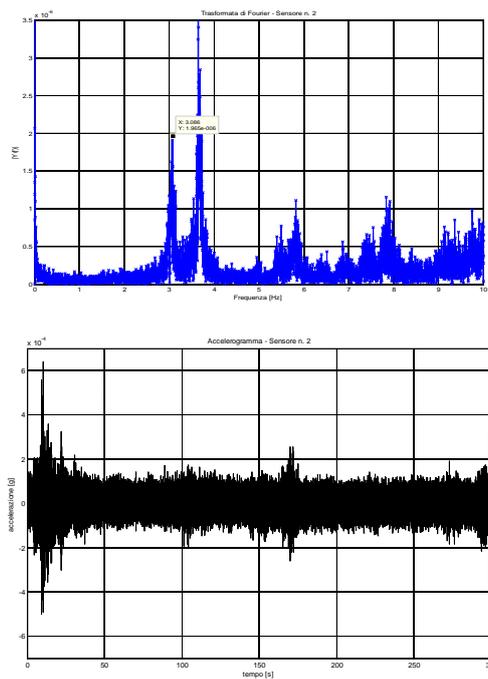
Figure 7: Fast Fourier transform and recorded signal. Accelerometer 2.

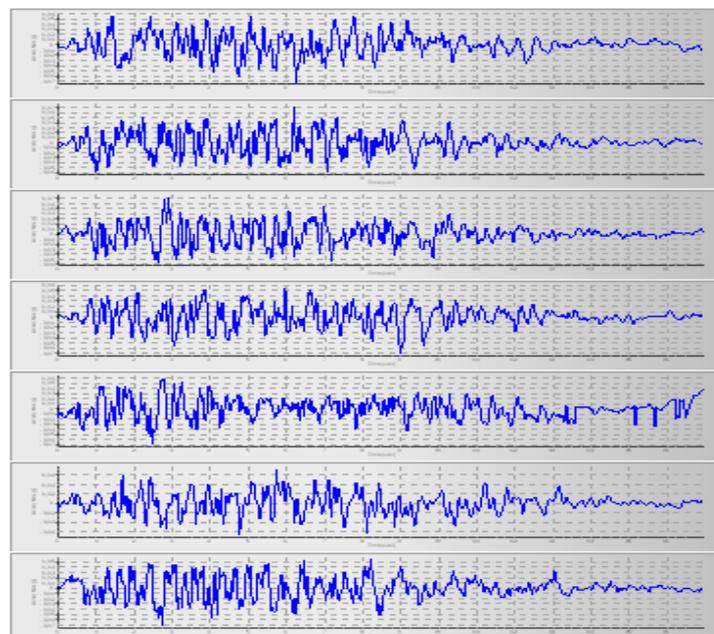
Figure 8. Artificial earthquakes for safety life state of the city of Casamassima

They have been generated from the spectrum target, provided by the Italian legislation for the city of Casamassima, through the software SEISMOARTIF ([www.seismosoft.it](http://www.seismosoft.it)), and suitably calibrated (Fig. 8), defining specifications of the selection and reducing the convergence error.

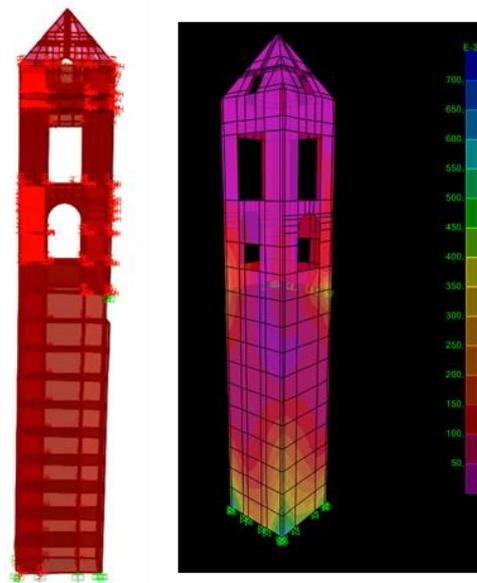
**Figure 9.** Compression stresses due to seismic load ( $\text{daN/cm}^2$ ).  $\text{PGA} = 0,07g$ ;

The analysis evidences that the tower is basically in elastic conditions, since the level of stresses is smaller than the strength in all parts of the tower. The structure is able to check all the collapse mechanisms with reference for the state limit adopted (Fig. 9). This does not imply the need to define and implement appropriate interventions to enhance the ability of the seismic structure.

As long as the seismic action increases its intensity, showing higher values of the safety life limit state, some cracks appear in the lower part of the upper block, mainly due to the "explosion" of some blocks for compression stress.

When the compressive stress is greater than the yield strength of masonry, the cracks begin to open. As the amplification factor increases, the high compression stresses appear further in the lower block until the structure collapses.

The PGA for the structural collapse of the tower of "Santa Chiara" is lower than the reference peak ground acceleration at the Life Safety Limit State ( $PGA_{\text{SLs}}=0.07g$ ), and so the risk index is  $\alpha_{\text{LS}}=PGA_{\text{Au}}/PGA_{\text{SLs}}=1.236$ .
