Assessment of Seismic Hazards for Unreinforced Masonry Structures in Turkey

ABSTRACT: Many people are living in unreinforced masonry (URM) structures, which constitute an important percentage of the building stock in Turkey. URM structures located on seismically active regions of Turkey are mainly non-engineered, deficient buildings. In this paper, earthquake damage to the buildings built using locally obtained materials, the material properties, and the architectural and load-bearing systems of these buildings were investigated and the sources of damage were determined. In addition, damage types which may occur in masonry structures are considered by reviewing the previous studies, causes of damages are investigated and solutions are suggested. Many researchers have been carried out on masonry buildings and strengthening methods for these buildings have been developed. The main purpose of the seismic strengthening is to upgrade the seismic resistance of a damaged building in order to make it becomes safer under future earthquake occurrences.

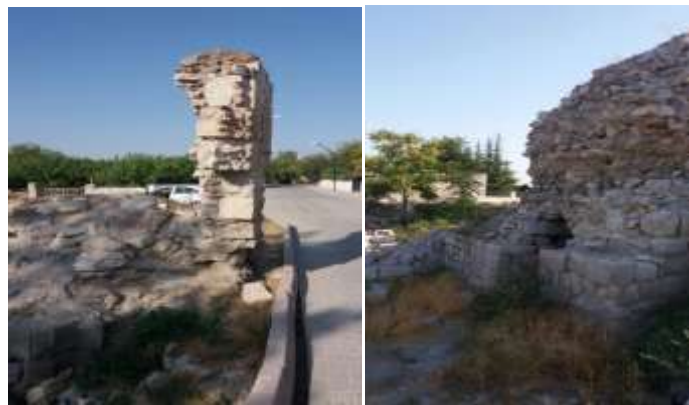
Figure 2. Out-of-plane collapse

General structural type of stone masonry and especially random rubble debris stone are used in Turkey. Structure of stone building is easy since they do not require reinforcement workmanship. Therefore, these buildings can enough be damaged. The damage is likely to occur in the unrestrained walls. The probable failure mode is out-of-plane collapse of the walls. Furthermore, in Figure 2, it is seen that, it is rolled and failed in the living space of the historical structure.

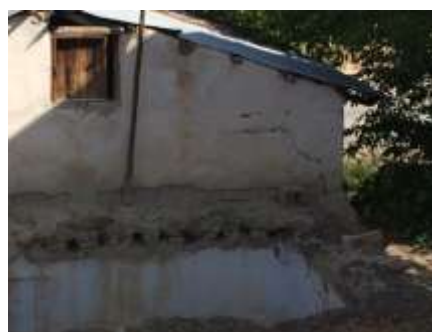
Figure 3. Corner failure in the presence of unconnected intersecting walls

The problem of unconnected intersecting walls is very common in Turkey. Because of bad connection detail of the intersections, safety of the connections relied on strength of the mortar used for connection. Unconnected walls were more tendencies to out-of-plane failures. Figure 3 demonstrated damages observed at intersection of outer walls. Damage, generally was concentrated around the opening area.

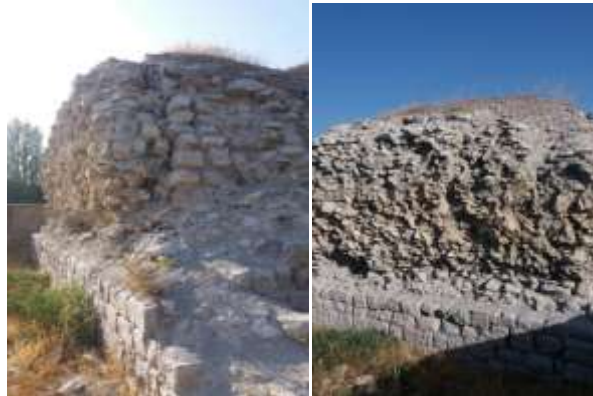
Figure 4. Stone dislocations and collapse

A major portion of the mostly single-story adobe buildings that were constructed in the traditional style entirely collapsed in Turkey [16-18]. The primary reasons for collapse in adobe buildings can be listed as the absence of masonry beams and columns which would protect the out-of-plane rigidity of the walls and the inadequacy of in-plane rigidity of the floors which connects the walls. Several cracks formed along the mortar and stone blocks on the sides during the earthquakes. Severe cracks and stone dislocations were observed at several critical locations. The wall damage was beside exposed inside the structure as it covers and plaster fell down at those critical locations.

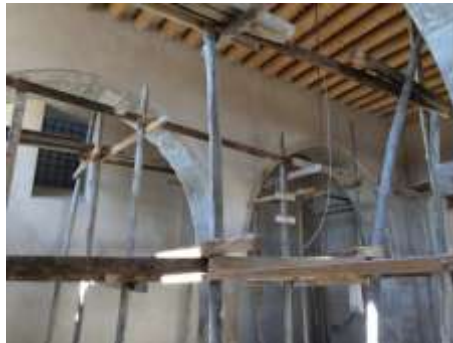
Figure 5. Shotcrete method

In the last decades numerous studies have been conducted concerning ways for strengthening and rehabilitation assessment for masonry structures. Many researchers investigated into retrofitting methods to improve the structures around the world [19–37]. Numerous conventional techniques used for retrofitting of unreinforced masonry structures in Turkey. Figure 5 shows that the use of the shotcrete method seismic strengthening applications for old construction. Shotcrete method called has been used repair for old construction for many years. Application of the shotcrete to surface of a masonry wall is a common method for strengthening both in-plane and out-of-plane strength of the walls. The strengthening using shotcrete significantly increases both shear and flexural capacities ultimate load of the retrofitted walls. The method have improves in-plane inelastic deformation capacity and dissipates high-energy due to successive elongation.

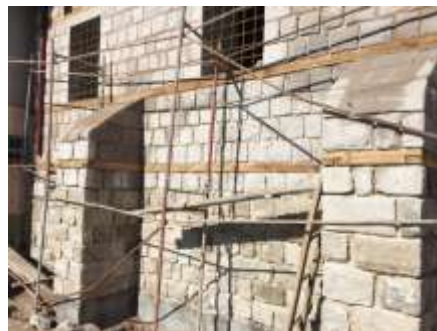
Figure 6. Re-pointing strengthening method

Re-pointing is a traditional retrofitting technique commonly used in the old masonry structures. This technique offers some advantages as reduced surface preparation and preservation of aesthetics. It might be provided as low cost and application of implementation. On the other hand, the method is not sustainable and the success of the lies with the compatibility of the new mortar. It demonstrated to sharply improve the shear and bending moment capacities of masonry improving decrease of deformation in Figure 6. The technique can integrate other repair technique as grout injection; in this case it may be applied so as to better confine the injected material.
